Operation TEAPOT

Project 31.2

DAMAGE TO COMMERCIAL AND INDUSTRIAL BUILDINGS
EXPOSED TO NUCLEAR EFFECTS

Bruce G. Johnston

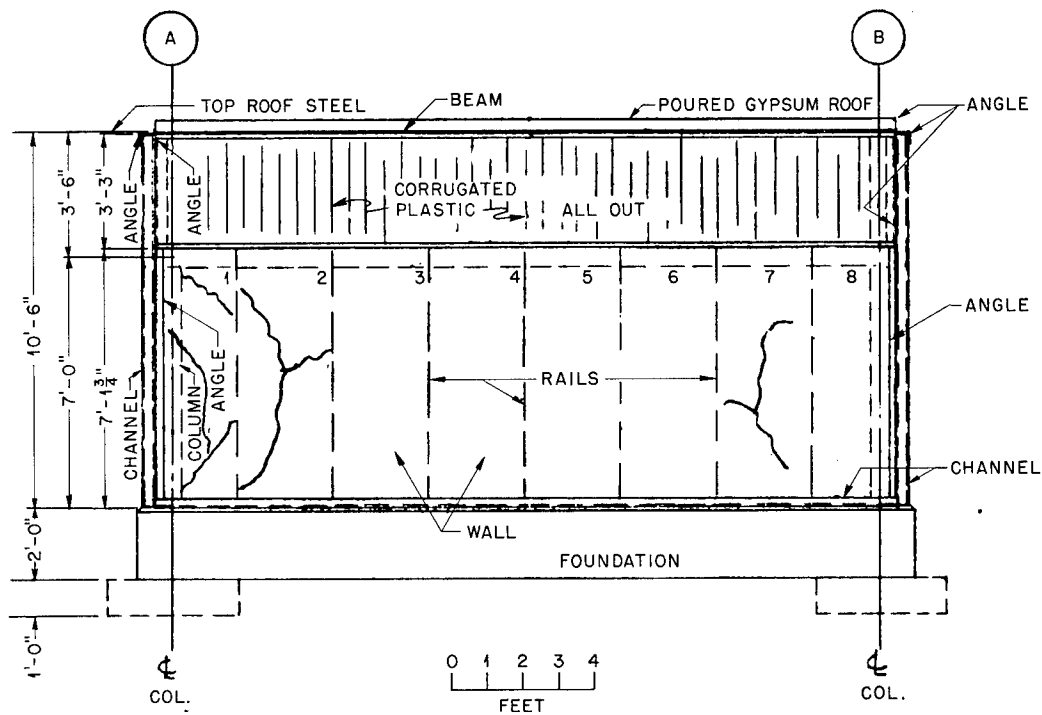
Fig. 1.3—Front elevation of Union Carbide building.

The reinforced-gypsum walls suffered only slight damage. The wall facing the blast (Fig. 1.3) showed moment cracks on the interior surface. These cracks were a maximum of $\frac{1}{32}$ in. in width, and they occurred in three of the panels formed by the vertical steel rail studs. The south wall, away from the blast center (Fig. 1.4), developed a horizontal crack approximately $\frac{1}{16}$ in. in width, starting near the southeast building column and extending across one-third of the bay. The east and west walls showed no moment cracks, but several shear cracks developed in the west wall at the top of the panels at roof level near the door opening, as shown in Figs. 1.6 and 2.16.

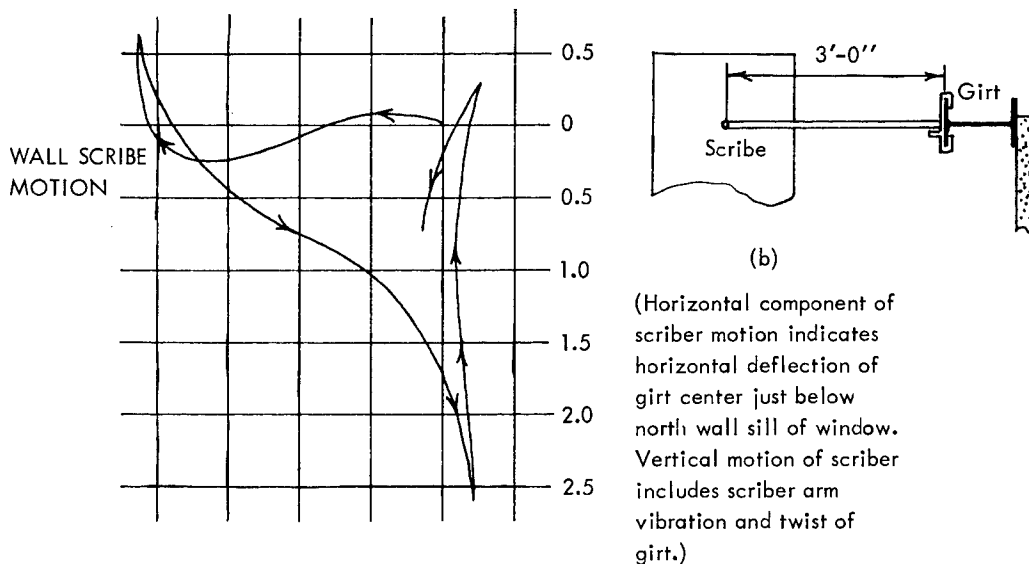
Severe vertical roof movements were indicated on scratchboards, and these movements are recorded in Fig. 2.14 at the one available location. No permanent deflections were recorded for any roof beams, except for the beam one panel from the south wall, which had a permanent upward deflection of $\frac{1}{8}$ in. at the center of the beam.

1. Horizontal girt in north wall: torsion and horizontal deflections, as shown in Fig. 2.14.
2. Roof girder at east wall: torsion in the girder, as shown by the impact mark on the scratchboard by the stylus pipe arm.
3. Roof beam, just north of center line: vertical displacement coupled with some torsional movement, as shown in Fig. 2.14.
4. Column in southeast corner (near girder): displacement approximately $\frac{1}{4}$ in. in north and south directions.

Fig. 2.14—Deflections of roof and north wall in Union Carbide building during planned test.

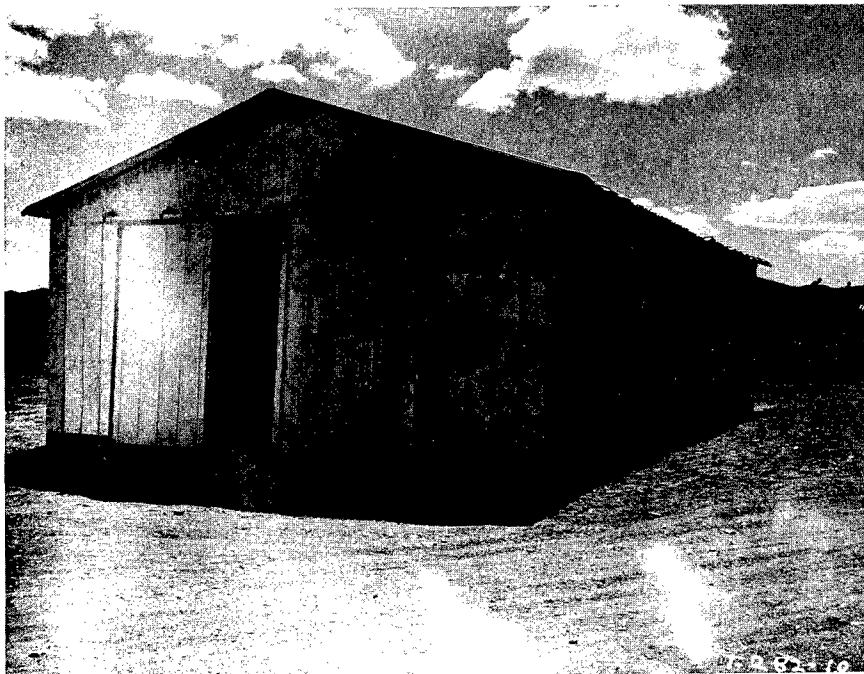
Fig. 2.49—East end of Reynolds-Butler Building 31.2-a2 after planned test.

A general description of these buildings is given in Sec. 1.3.2, and general drawings, are shown in Figs. 1.10 and 1.11. Over-all behavior during the unexpected test is described in Secs. 2.1.2 and 2.1.3, and behavior during the planned test is described in Secs. 2.2.3 and 2.2.6. Figure 2.1 shows the wall after the unexpected test, and Fig. 2.2 records the measured offsets of permanent wall deflection after both the unexpected and planned tests. Figures 2.3 to 2.5 show other views of damage to the walls and roof which resulted from the unexpected tests, and Figs. 2.46, 2.48, and 2.49 show the wall condition after the planned test at the 15,000-ft line.
